BULLETIN 086/SE/TC

1M1 (Leon) / 1M2 (Toledo) Water ingress through doors

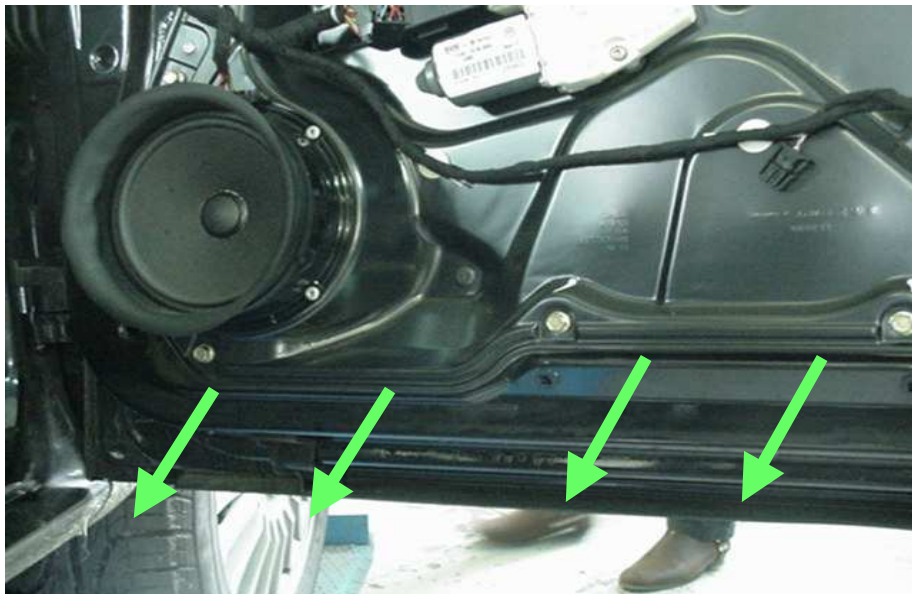
Unfortunately there may be a problem with the original seals on the ancillaries carrier (on Leon only), allowing water to get through. *(fig.1)*

figure 1 - Path of water ingress

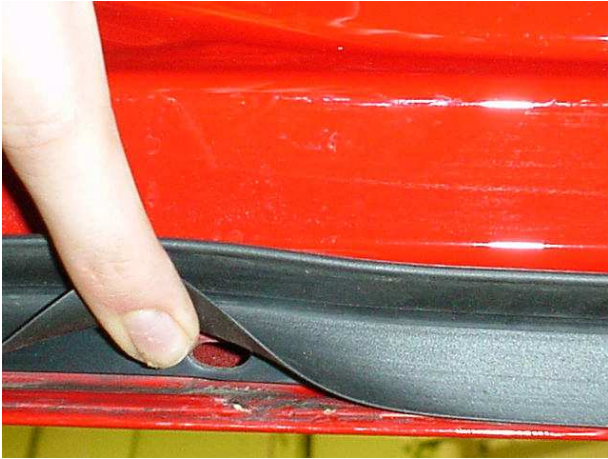
1. The outer weather seal along the bottom of the doors seals up the door drain holes. *(fig.2)* Water cannot drain out and builds up inside the door, potentially entering the vehicle interior via the ancillaries carrier seal or speaker aperture.
2. The ancillaries carrier should be sufficiently water-resistant to prevent water draining from the top of the door from entering the vehicle.

figure 2 - Outer weather seal on door - (view from below)

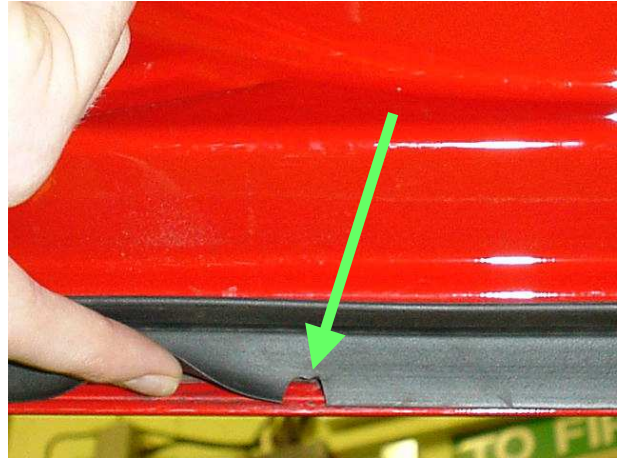
figure 3 - Cut notch in weather seal as shown

1. Cut a small notch in the weatherseal adjacent to each drainhole. *(fig.3)*
2. Remove the ancillaries carrier from the door. Remove the original seal and any adhesive remaining around the carrier. *(fig.4)* To avoid damage to the paint, use a plastic wedge, or similar. Replace the seal with sealing cord, part No. **AKD 497 010 04R10**. *(fig.5)* Refit the carrier.

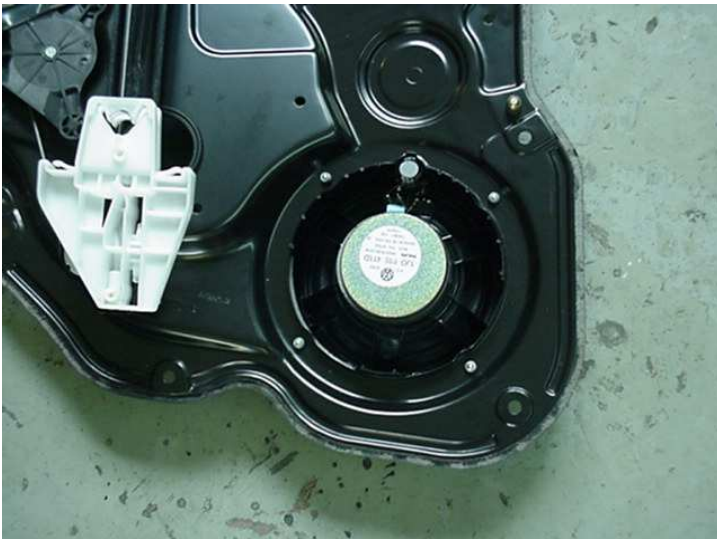
figure 4 - Remove old seal from ancillaries carrier

When cleaning please take care not to damage the paint!
(Use a plastic wedge or moulded plastic part)

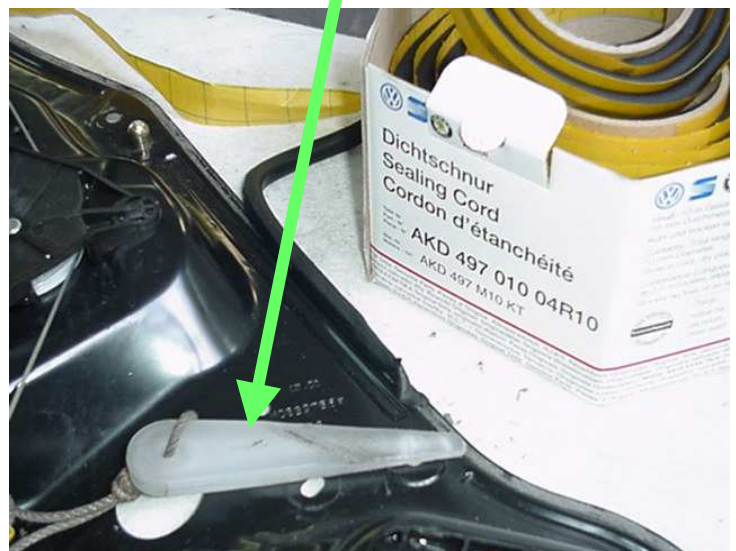
figure 5 - Replace seal with sealing cord
